TECHNICAL REPORT N-78-1

EXPEDIENT UPGRADING OF EXISTING STRUCTURES FOR FALLOUT PROTECTION

William L. Huff

Weapons Effects Laboratory
U. S. Army Engineer Waterways Experiment Station
P. O. Box 631, Vicksburg, Miss. 39180

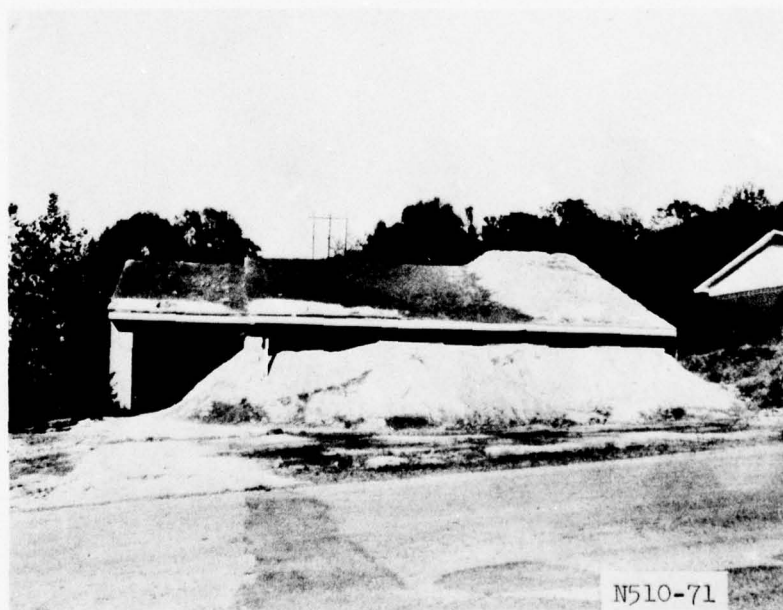
With the weight of the wet soil for several days, the deflection increased to 15/16 inch. Figure 2.25 shows the house after the rain. Water seeped under the soil roll around the edge of the roof; however, none of the soil had washed off. When the roof was inspected on Monday, the 2 by 4 braces at the center of the truss were bowing as much as 1-1/2 inches. Some of the bowed braces can be seen in Figure 2.26. When the house was inspected on Tuesday, one of the truss braces had broken (Figure 2.27) at the location of a knot. The roof in that area sagged approximately 2 inches, and the recorded deflection locations showed an average deflection of 13/16 inch. Apparently, when the roof sagged over the broken truss, it bowed up slightly in the areas in which deflections were being recorded.

Figure 2.25 Completed shelter after weekend rain.

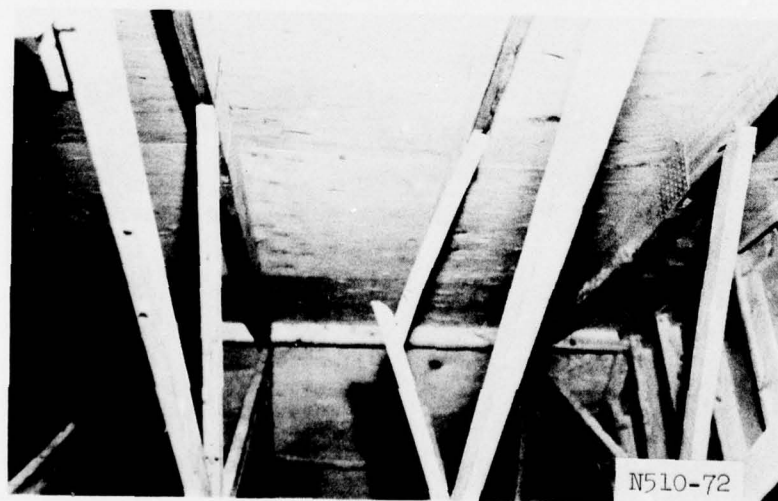
From soil density measurements, the loading on the frontside and backside of the roof in the structural test area was 180 and 130 psf, respectively. Since one of the braces in a truss had broken under this loading, no additional soil was added to the roof. The 3/8-inch-thick plywood sheathing had not bowed sufficiently between the trusses to obtain reliable deflection measurements. At most, the plywood had sagged 1/8 to 1/4 inch between the trusses.

Figure 2.27 Broken truss member.

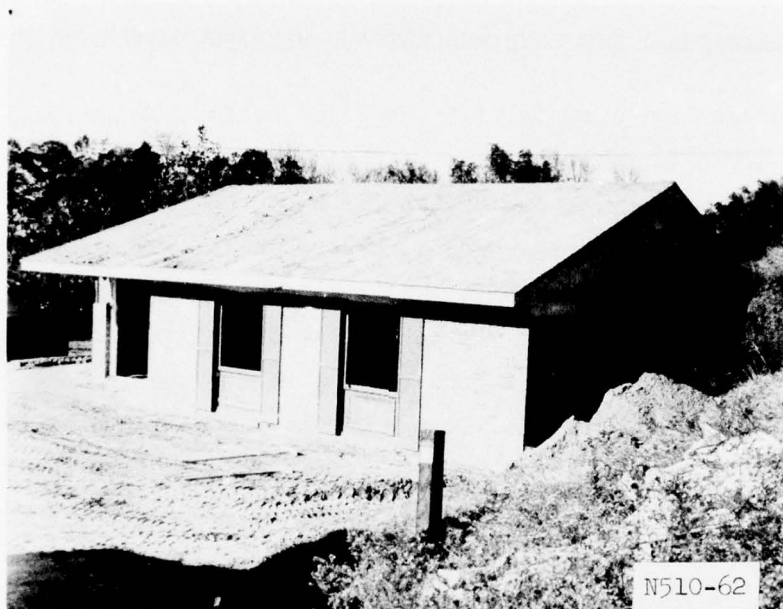
Figure 2.28 shows the house with the soil removed, and a closeup of the brickwork on the end of the house is shown in Figure 2.29. Due to limited space at the ends of the house, the garage roof and walls were torn down to allow the front-end loader access to the backyard where the soil was dumped. The entire house including the concrete slab foundation had to be removed from the lot upon completion of the test. The only damage to the house from the soil loading was the broken brace in one of the roof trusses. Soil remaining on the brickwork could be swept off with a stiff broom. Soil remaining on the roof had to be washed off. The interior doors used to cover the two front windows were undamaged and reusable.

Figure 2.28 House with soil cover removed.

The entire house lot needed grading and seeding to put the house site back into its original condition. Had the shrubbery from around the house been removed carefully it could have been replanted in its original location.

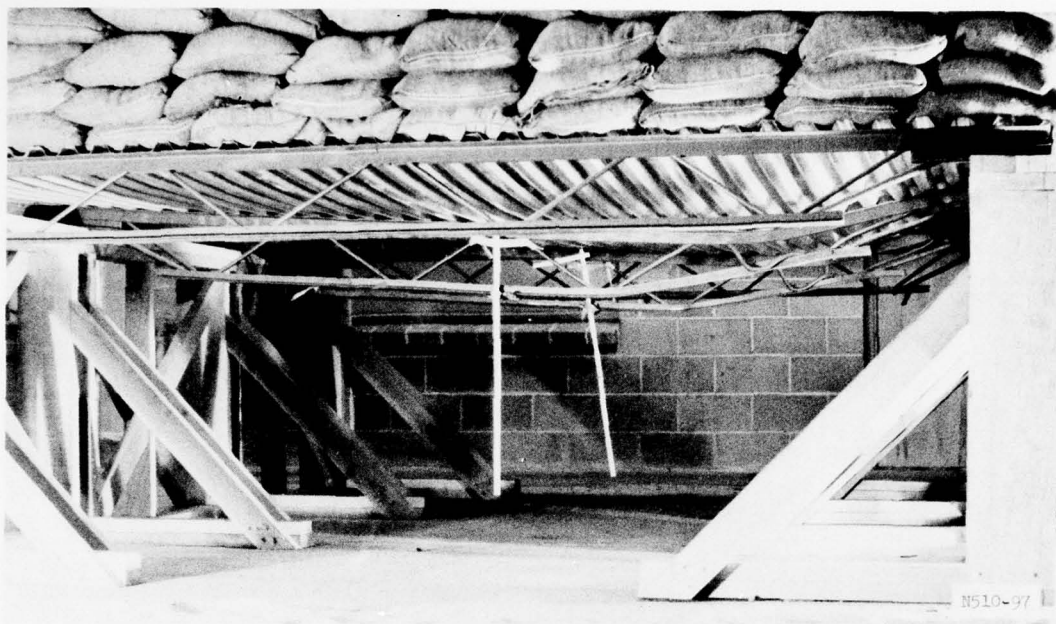
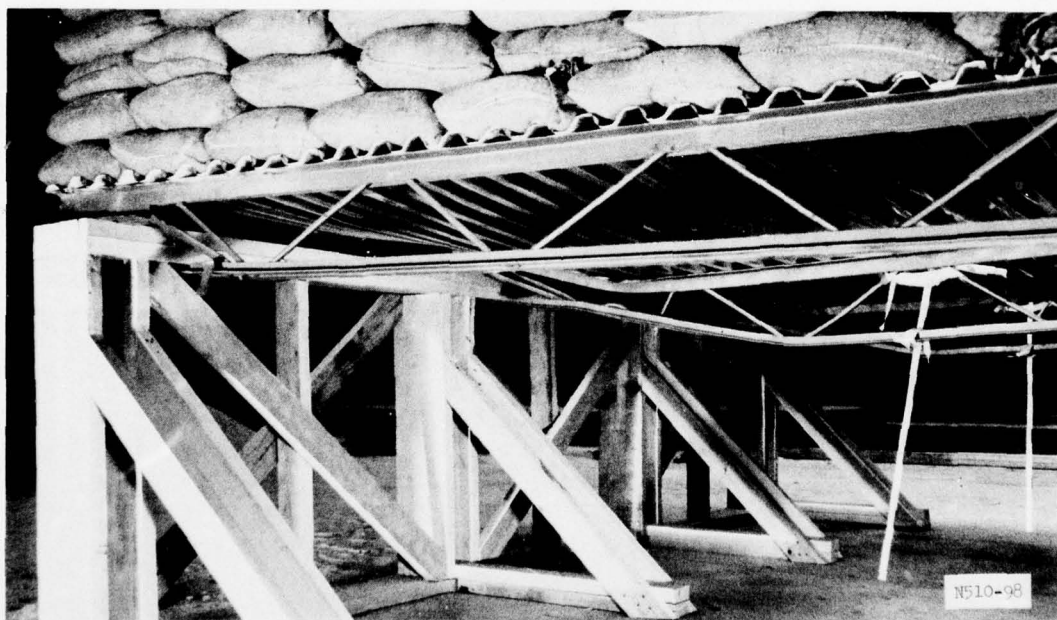
Since the decking was failing rather than the joists, the test was stopped. As the sand was being removed for a closer inspection of the metal roof decking, the two center joists started to fail. Figure 3.7 shows the initiation of the failure at the second web member from the end of the joist. The two middle joists of the roof system are shown in Figure 3.8 after removal from the roof. The two outside roof joists were undamaged.

From the truss analysis, the web member that failed was being subjected to an axial force of 8000 pounds. Assuming pinned connections, the calculated critical buckling load from the Euler formula was 4600 pounds. If the ends are assumed fixed, the critical buckling load is 18,500 pounds. Although the web members of the joists are continuous and welded at each intersection with the top and bottom chords, they are acting more as a pinned end member than a fixed end member.

a. View of damaged joist from the west side.

b. View of damaged joist from the east side.

Figure 3.7 Initial buckling of the OWJ.

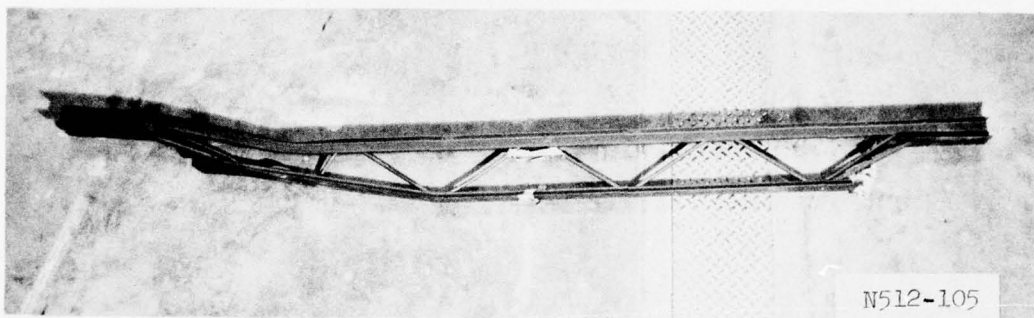
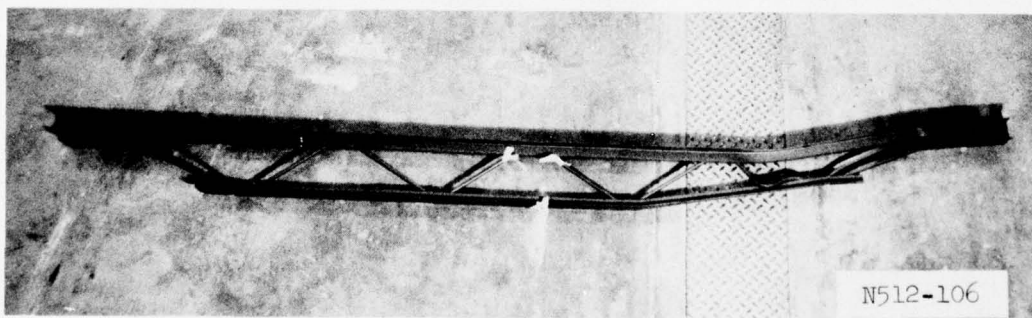
a. West side of joist No. 2.

b. East side of joist No. 3.

Figure 3.8 Overall view of damaged 10-foot OWJ.

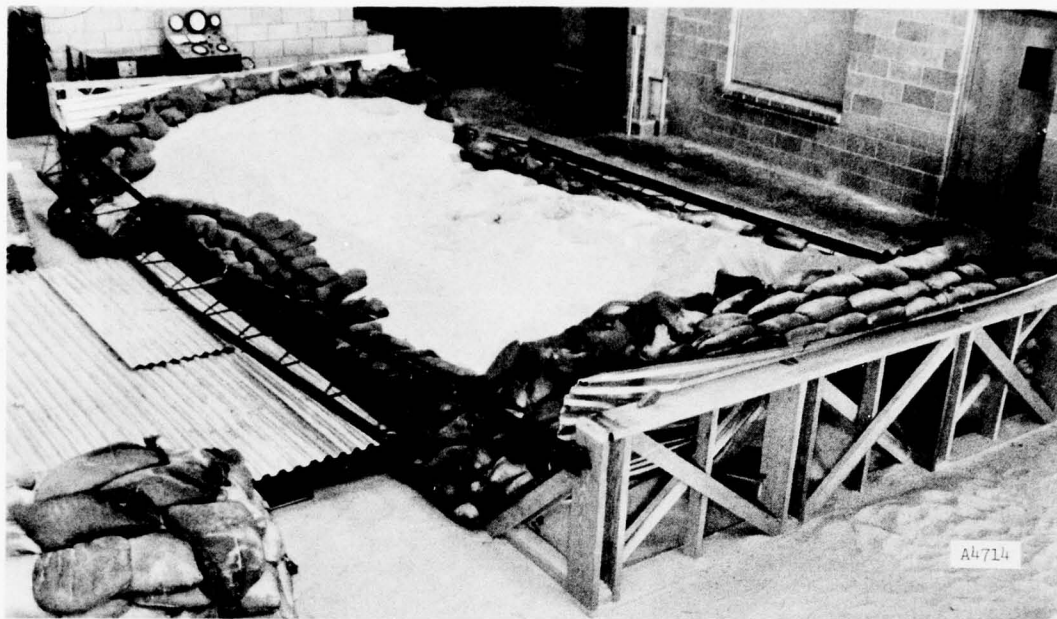
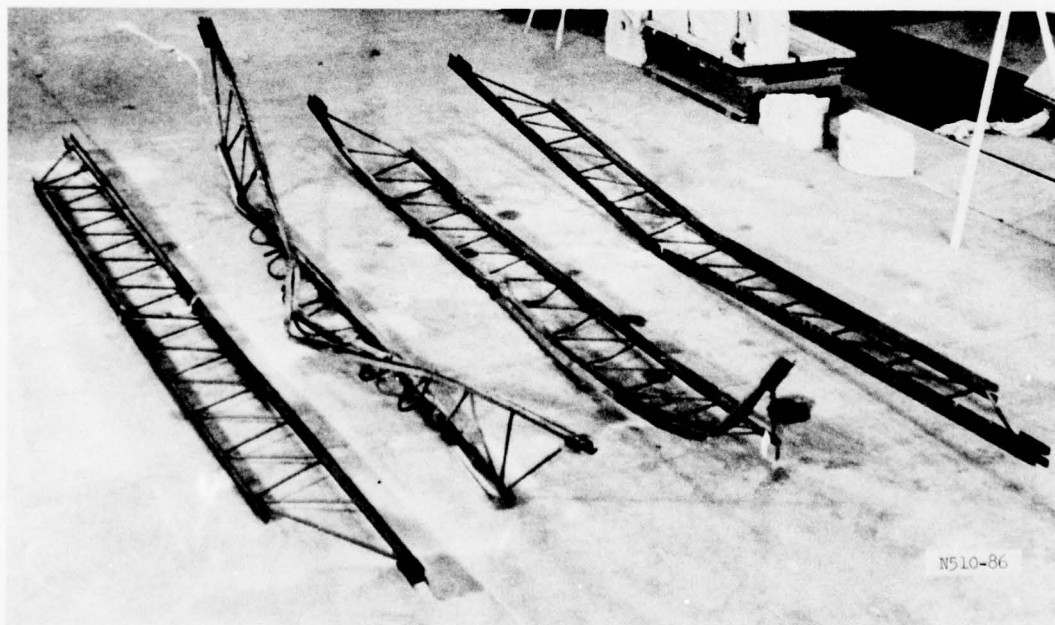
a. Collapsed OWJ roof system.

b. Joist with sand and metal decking removed.

Figure 3.10 Twenty-eight-foot span OWJ roof after collapse.

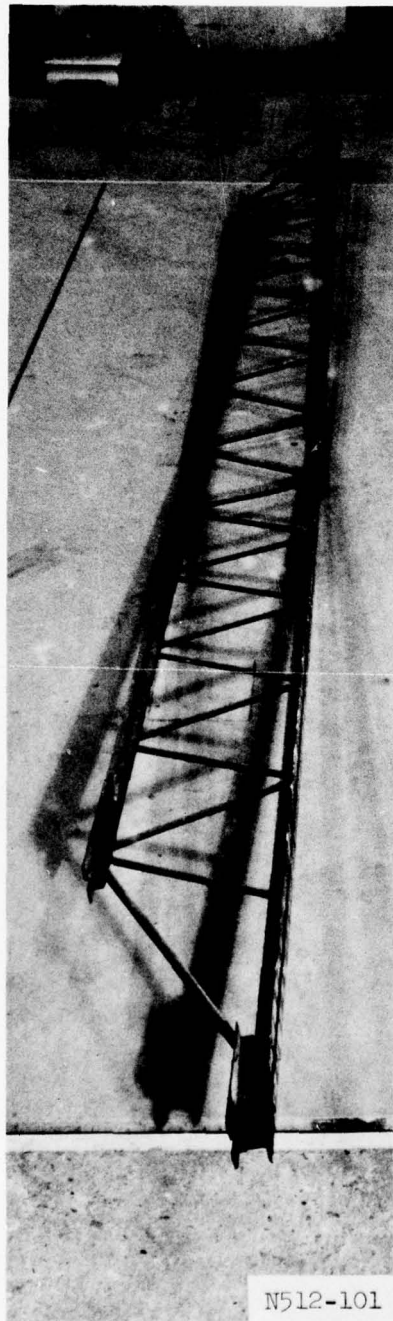
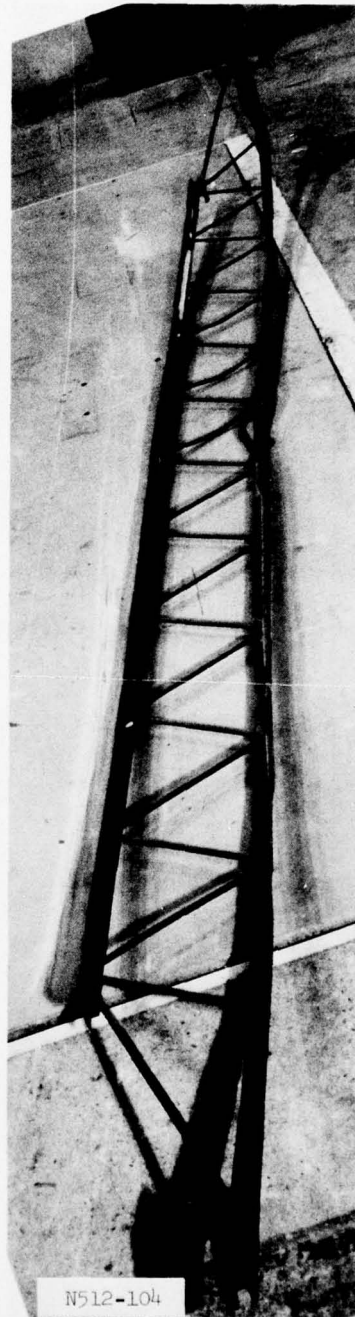
a. Joist No. 1.

b. Joist No. 2.

Figure 3.11 Closeup of individual joist after failure (sheet 1 of 2).

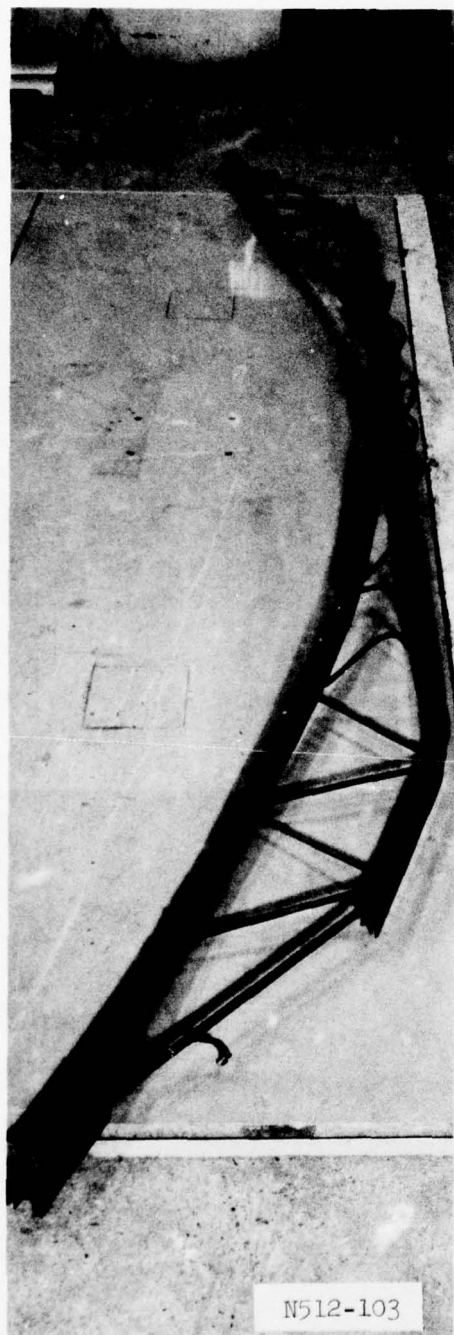
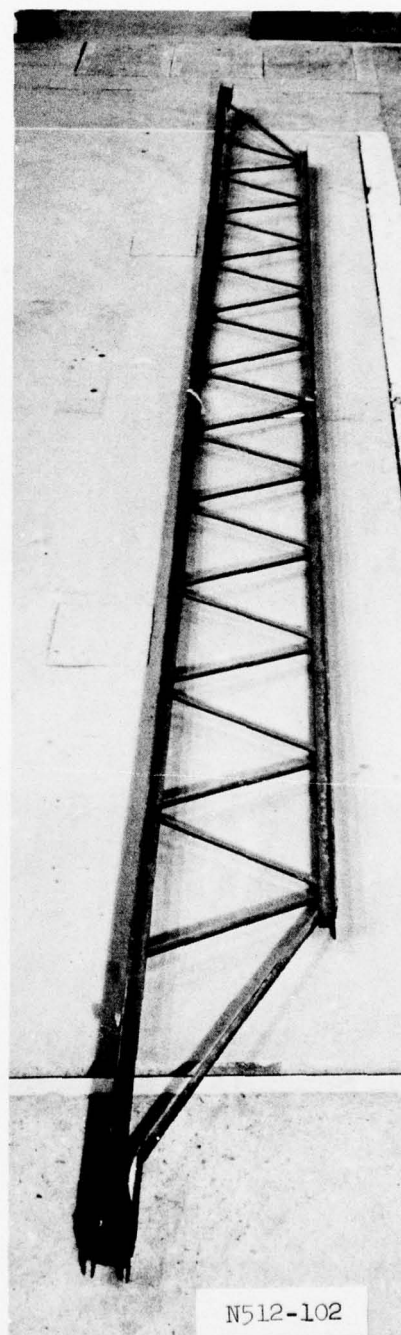
c. Joist No. 3.

d. Joist No. 4.

Figure 3.11 (sheet 2 of 2).

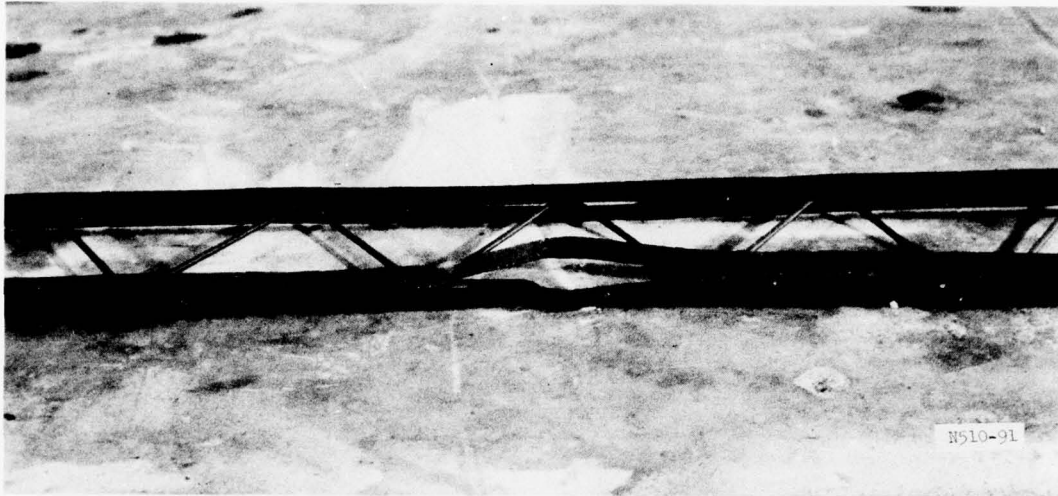
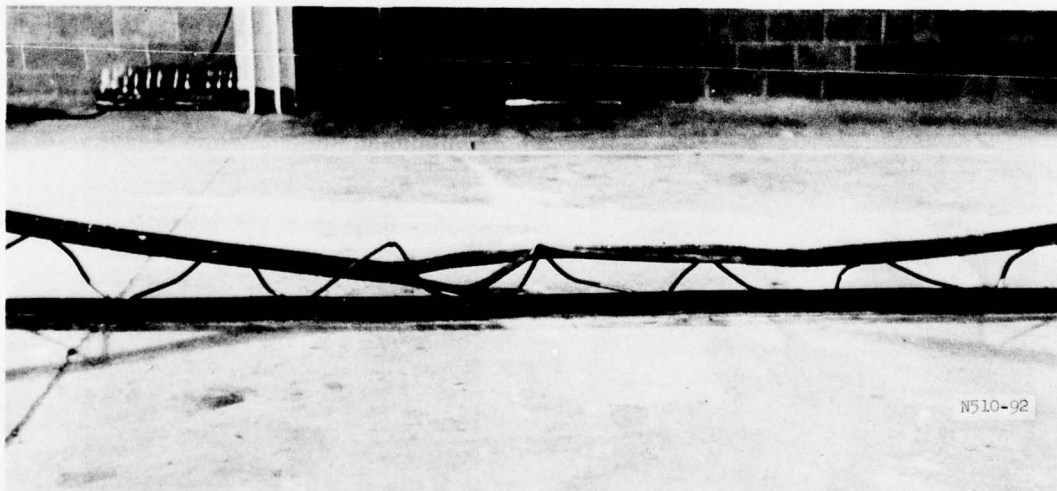
a. Buckled top chord of joist No. 2.

b. Central section of joist No. 3.

Figure 3.12 Closeup of major damage to joist Nos. 2 and 3.

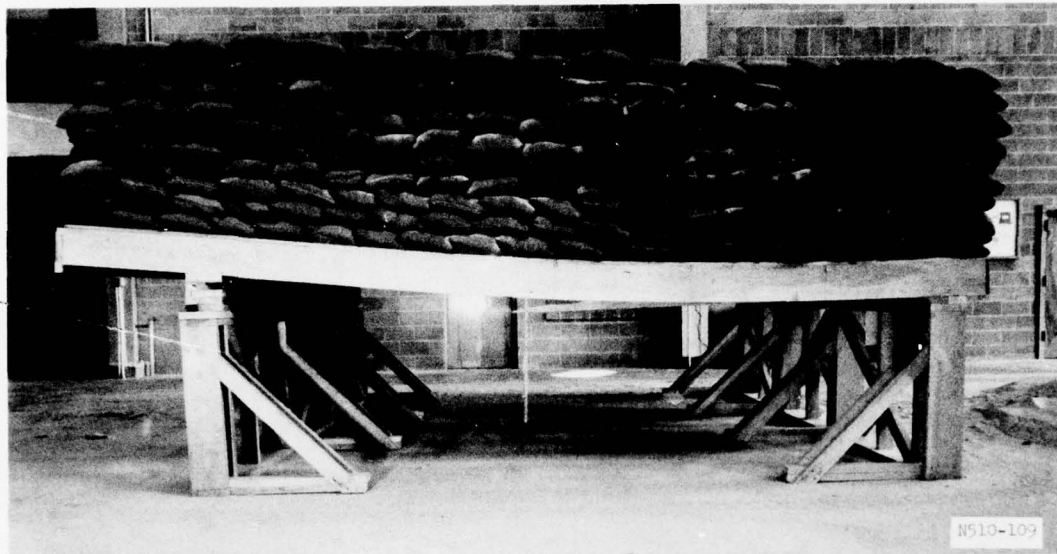
a 24-hour period with a loading of 24 inches of sand. When the load was increased to 36 inches of sand (300 psf), the roof supported the load for several hours before one of the joists failed. The split section of the failed joist can be seen in Figure 3.25. The failure occurred in the joist next to one of the edge joists of the roof.

Figure 3.25 Wood joist roof after joist failure.

required for radiation protection. Before loading any wood floor or roof system, the joists and decking should be inspected closely for obvious defects in materials or construction.

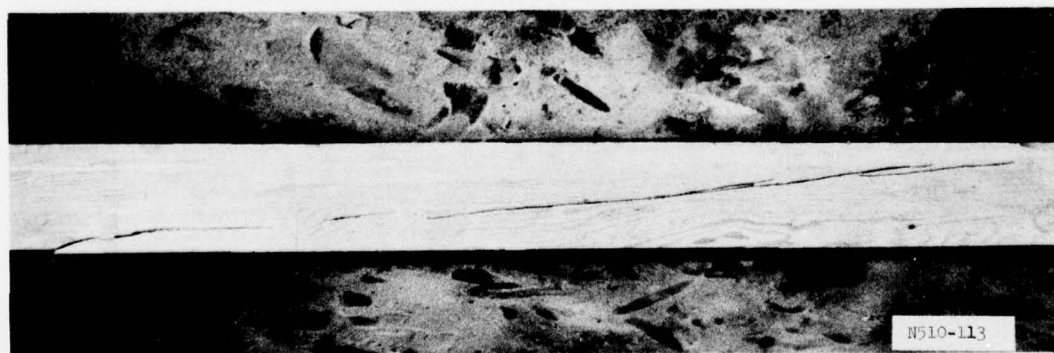
The failure plane of the broken joist extended along the wood grain from near midspan on the underside of the joist to within 1-1/4 inches of the top of the joist at approximately 4 feet from midspan. Figure 3.26 shows a closeup of the broken joist after it was removed from the roof section.

Figure 3.26 Closeup of broken joist.
